## RETRIEVAL ANALYSIS OF SOME CEMENTLESS HA-COATED SMOOTH SURFACE ACETABULAR IMPLANTS

[I Antoniac<sup>1</sup>](#), [D.Lăptoiu<sup>2</sup>](#), [M. Miculescu<sup>1\\*</sup>](#), [V.Bunea<sup>1</sup>](#), [F.Miculescu<sup>1</sup>](#),

<sup>1</sup> Politehnica University from Bucharest, Romania, <sup>2</sup> Colentina Clinical Hospital, Romania.

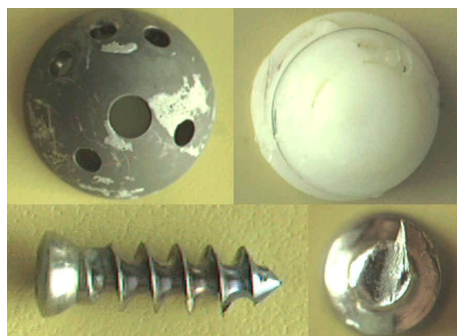
*Fig. 1: Macroscopy view of the primary implant components who was analyzed: acetabular cup, polyethylene liner, screws.*

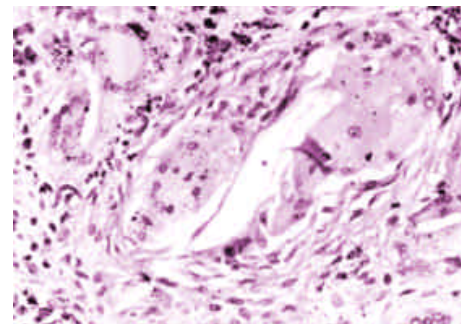
**RESULTS:** The primary implants - cementless HA coated smooth surface (Landos, France) had a HA coating of 60 micrometers thick and 5 screw holes on the surface. Tissues samples retrieved at the time of revision surgery for a migrated cementless acetabular implant associated with important osteolysis have demonstrated a consistent histological pattern. All intraoperative bacteriological cultures were negative. The most common finding was extensive chronic inflammation with a predominance of plasma cells and lymphocytes. Other anatomo-pathologic features included granulomas, foreign-body giant cells, necrosis, and fibrin exudation (figure 2). Each acetabular cup was removed with as much care as possible with regard of the bone stock and surrounding tissues. Gross inspection at the retrieved acetabular liners revealed a group of changes.

*Fig. 2: Histological view of the tissue surrounding the implant under light microscopy. 1-foreign bodies, 2-foreign body inside giant cell, 3-giant cell and fibrin exudation; (hematoxilin Eosin, coloration of sample tissues; x 200)*

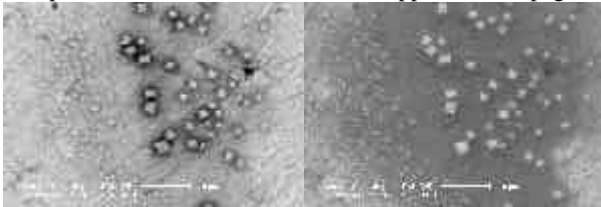
Backside deformity with loss of machining lines, important backside markings around the screw holes, minimal wear inside the cup, advanced wear along the peripheral rim where impingement occurred. The digital analysis of the implants showed the degree of bone ingrowth at an average of 10 to 15% and the HA resorbtion extent averaged from 60 to 85% of the surface. ESEM analysis showed two patterns. The Ti6Al4V alloy type screws presents unhomogenous material, surface morphology analysis indicates a fatigue screw breakage type of failure, probably because of presence of the poliedric compounds with different composition compared with base metal (fig. 3).

Fig. 3: Scanning Electron Microscopy (SEM) of the screw breakage area: left-BSE, right-LFD (x2931); note the poliedrical compounds with a visible different composition than surrounding metal basis, a possible source for weakness and failure.

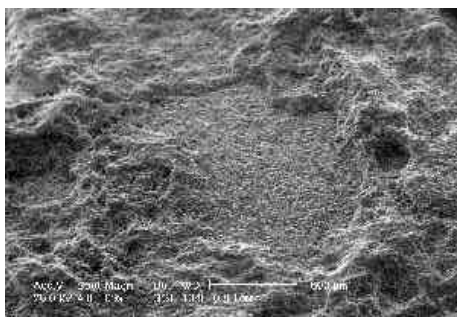
The up surface of acetabular cup presents three different zones: base material porous type-titanium, remnant areas covered with hydroxy-apatite and areas polished by fretting (fig. 4).

Fig. 4: Scanning Electron Microscopy (SEM) of the external surface of the acetabular shell (x69); note the difference in porosity between HA coated area and TiAlV smooth metal surface.

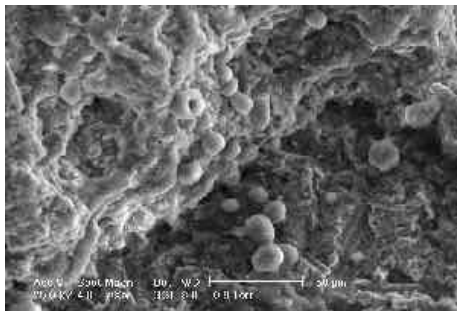
Fig. 5: Scanning Electron Microscopy (SEM) of the same area of the acetabular shell at the interface HA-metal (733X); note the important cell adhesions (bone and erythrocytes) related to the remnant HA in contrast with the smooth surface.
