Microscopy analysis of total knee prosthesis failure caused by polyethylene wear

[Antoniac Iulian](#)¹, [D.Laptoiu](#)², [F.Miculescu](#)¹, [R.Istrate](#)³, [C.Trisca-Rusu](#)⁴

¹University "Politehnica" of Bucharest, Faculty of Materials Science and Engineering; ²Colentina Clinical Hospital, ³Med4Med Group Ltd, Bucharest, ⁴IMT Bucharest, Romania

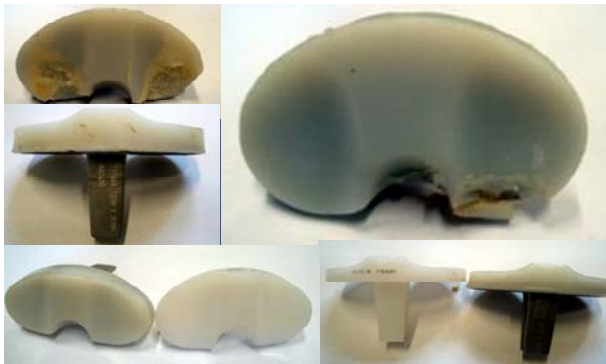
Fig.1: Example of some retrieved polyethylene components from knee prosthesis

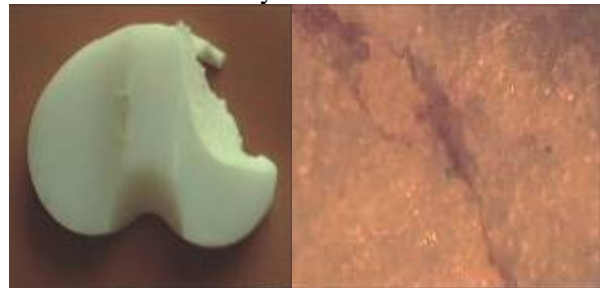
RESULTS: Different modes of surface degradation were identified: burnishing; pitting; depressions in the articulating surface; surface deformation (caused by cold flow and/or creep); abrasion caused by direct contact with bone-cement debris; scratching; delamination. In our retrieved specimens, both longitudinal and transverse wear patterns "ripples" were observed consistent with the "natural" sliding and rolling movement of the knee. Another observation is related to the surface delamination of the surface observed by SEM, with a low uniformity of it,

possibly related to a shelf aging phenomenon. This may also explain the relative agglomeration of revision cases in one year time interval.

Fig.2: Macroscopic aspects of polyethylene components (left); stereomicroscopic image from failure zone (right)

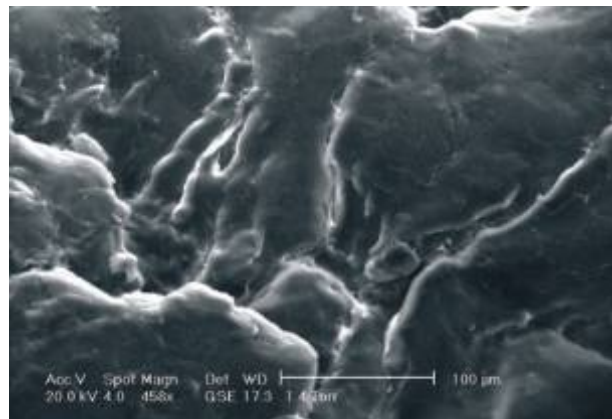
Fig.3: Scanning electron micrographs of retrieved polyethylene components (successive delamination was observed)

DISCUSSION & CONCLUSIONS: Some knee implants are more "forgiving" versus the surgical technique; generally, small rotational errors ($\pm 5^\circ$) are consistent with surface damage of the tibial insert. Burnishing, scratching and abrasion are the mechanisms mainly involved in these failures; most damage was seen at the posteromedial area. Delamination and surface deformation are connected to shelf or service life wear. The damage mechanisms of polyethylene components are dependent on the component geometry, the sliding conditions, and the shelf to service lifetime of the implant.
